RAILWAY INVESTIGATION REPORT
R99S0100

CROSSING COLLISION/DERAILMENT

VIA RAIL CANADA INC.
PASSENGER TRAIN NO. 85
MILE 33.54, GODERICH-EXETER RAILWAY
(GEXR) GUELPH SUBDIVISION
LIMEHOUSE, ONTARIO
09 NOVEMBER 1999

Report Number R99S0100

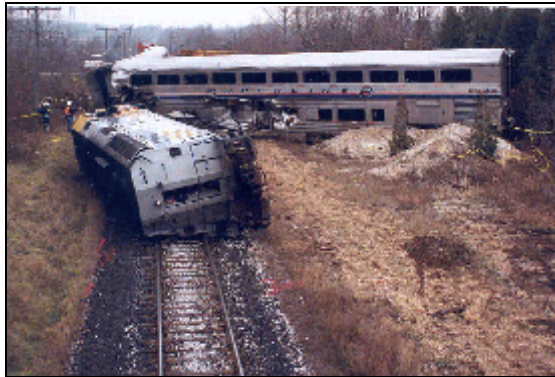
The first car behind the locomotive tracked westward, in the derailed position, until it became detached from the locomotive. It travelled in a west-southwest direction, stopping 362 feet west of the crossing, perpendicular to the track. The following three coaches tracked parallel with the main track, leaning at varying angles. The back end of the last car came to rest at a point 52 feet west of the crossing.

Figure 1 - Accident site, looking east to the crossing.

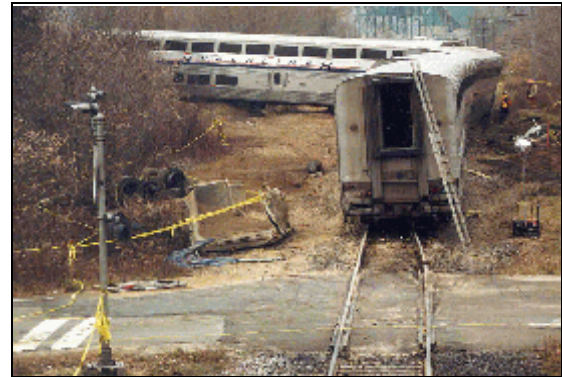
Figure 2 - Accident site, looking west from the crossing.

The dump truck, which weighed approximately 34 tons with its load, was dragged westward and thrown in a southwesterly direction. The frame and operating compartment of the truck came to rest upside down in a ditch, 120 feet south of the track and 33 feet west of the crossing. The dump box was ripped from the truck frame and propelled 63 feet west of the crossing and

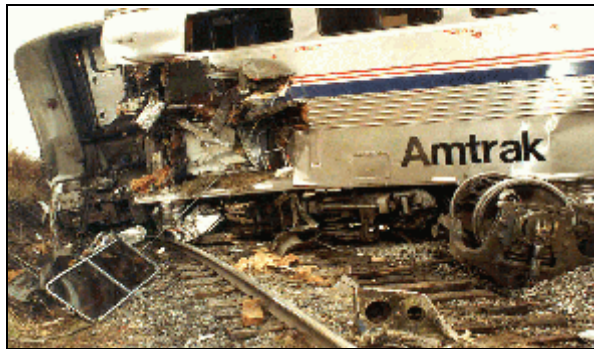
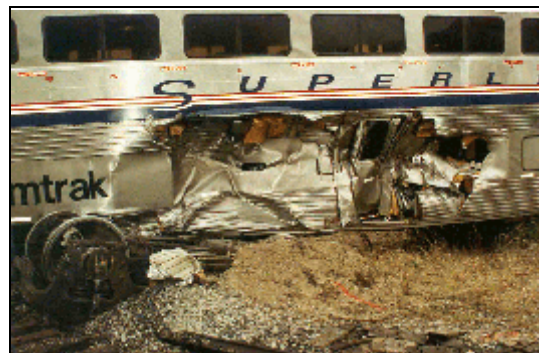
AMT coach 34036, the first (lead) car behind the locomotive, sustained major damage to the right (north) side. When the locomotive separated from its trucks, the lead car was dragged westward, striking the displaced locomotive trucks. Just east of the mid-section of the car, a large section of the stainless steel sheeting, measuring 6 feet 3 inches high by 20 feet 3 inches long, was torn away by the impact. The double-occupancy seats in this area were exposed to the outside, and the stairwell to the upper level seating was crushed. A large hole at the extreme east end of the car, measuring 6 feet 3 inches high by 11 feet long, destroyed the compartment housing electrical and plumbing controls for the operation of the car, and a window was ejected from the upper level. A total of 12 Z-type construction posts were destroyed along with approximately 35 feet of longitudinal channel beam. This coach eventually separated from the locomotive and came to rest across the main track, causing additional damage to the undercarriage.

Figures 3 & 4 - Damage to coach 34036

Heavy post-accident damage to the coaches resulted in deformation of the car body and upper deck stairwell, which heavily impeded egress from the washrooms and upper seating area. The side sheathing and structural side post of AMT 34036 were extensively damaged when the coach struck the detached locomotive trucks, tearing a large hole in the side sheathing. The cars are designed to resist an inward transverse load; however, the loads experienced were in excess of the design requirement.

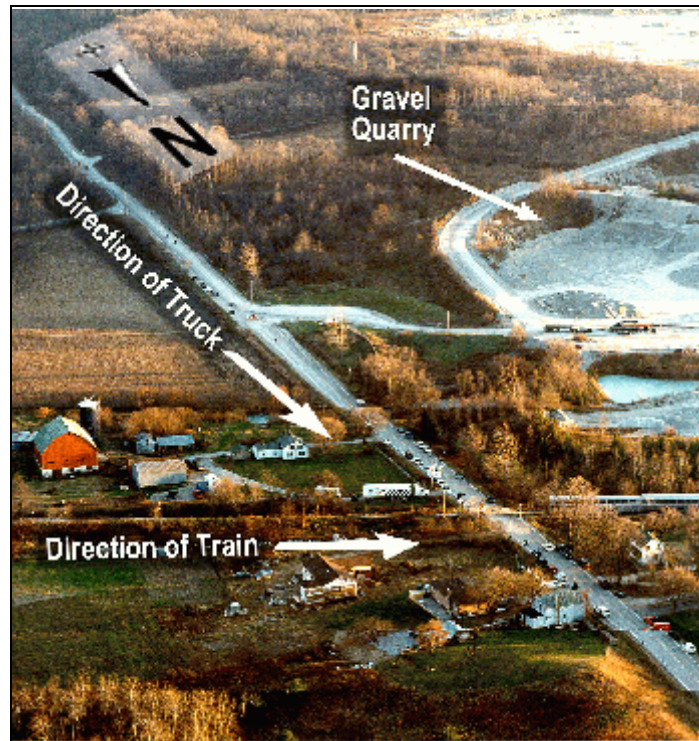
Figure 5 shows an aerial view of the site taken just after the accident. The area surrounding the occurrence site was primarily rural/residential with homes in three of the four quadrants. The southwest quadrant has a large earth bank obscuring an eastward train movement from 100 feet south of the crossing. A growth of trees, shrubs and other vegetation concealed a commercial gravel pit operation 360 feet south of the crossing. A grove of trees and shrubs stretched approximately 200 feet south along the east side of the roadway and 500 feet east along the railway tracks.

The southeast quadrant, which lay between the truck and VIA 85, had a number of private dwellings and buildings, large trees, decorative shrubs and other vegetation that partially obscured westward train movements from northbound drivers. More than 200 feet (60 m) south of the crossing, the sight line to the east was completely obstructed by buildings. At 200 feet (60 m), the sight line to the east was 760 feet (228 m). Closer than that, the trees and shrubs blocked the southeast quadrant sight line until 100 feet (30 m) from the crossing, where the sight line to the east was 150 feet (45 m). At 50 feet (15 m), the sight line to the east was 225 feet (67.5 m).

Figure 5- Aerial view of crossing looking south.

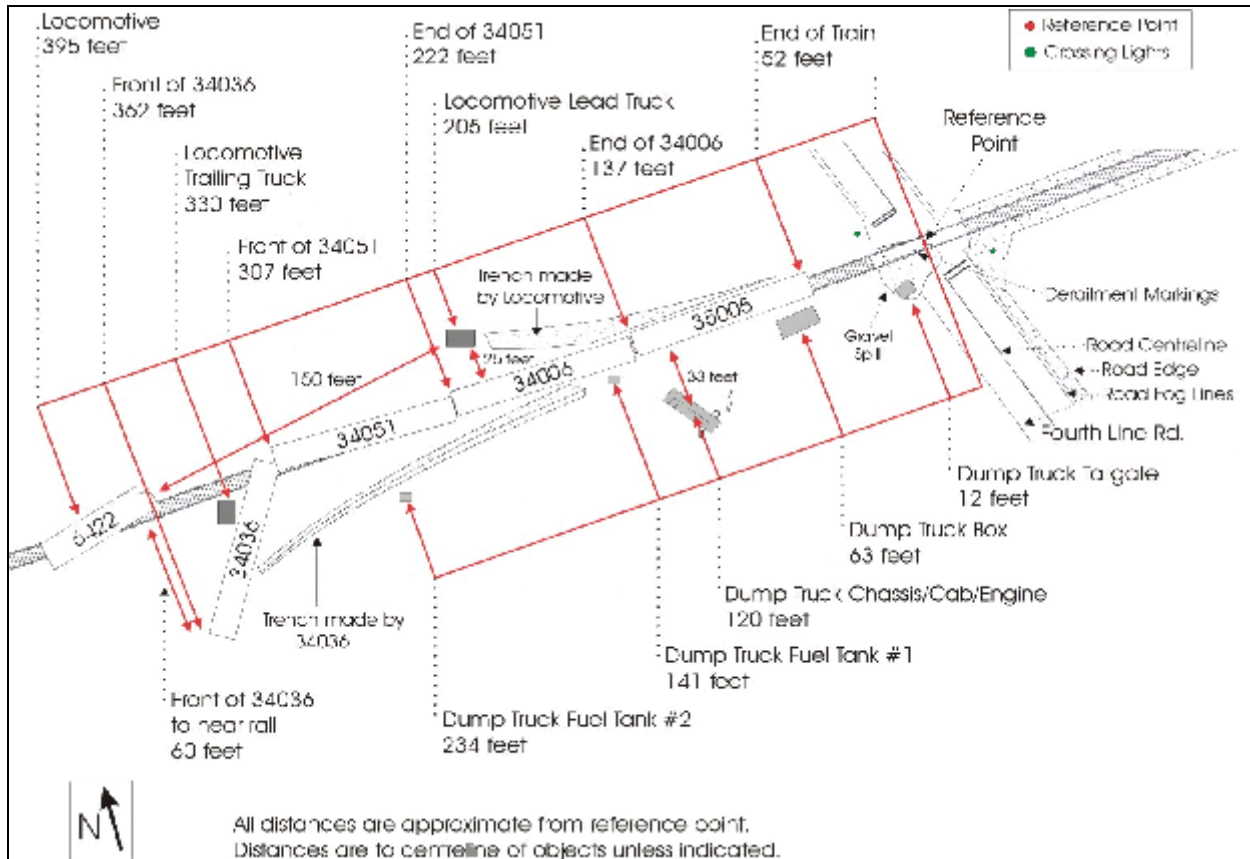
Appendix A—Diagram of Accident Site

15 feet south of the track. Parts of the truck were strewn on both sides of the track as far away as 234 feet from the crossing. Appendix A contains a site diagram showing approximate locations and measurements
